Postoperative Surgicel Mimicking Pelvic Abscess Causing Mechanical Bowel Obstruction following Abdominal Hysterectomy

Mariam Mathew^{1*}, Jai kumari¹, Asma Fauzi² and Rashid Al Sukaiti³

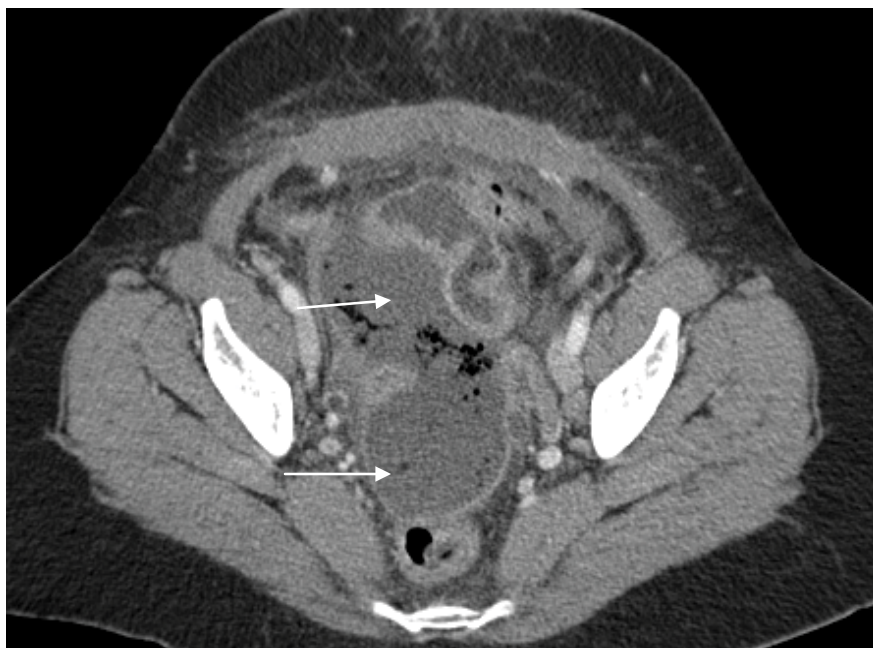
Figure 1: Axial Image of a computed Tomography that demonstrates a multiloculated rim enhancing abscess containing multiple pockets of gas in pelvis (White arrow).

ed Tomography (CT) scan of pelvis on 6th postoperative day showed a well-defined hypodense area with rim enhancement and internal pockets of air, anterior to the rectum extending to the right side of the abdomen ([Figure 1](#)). It measured 12 × 6 cm suggestive of collection/abscess. Small bowel loops were dilated with collapsed large bowel. The initial impression was pus collection in the pelvis extending to the right side of abdomen causing mechanical obstruction of ileum. Even though there

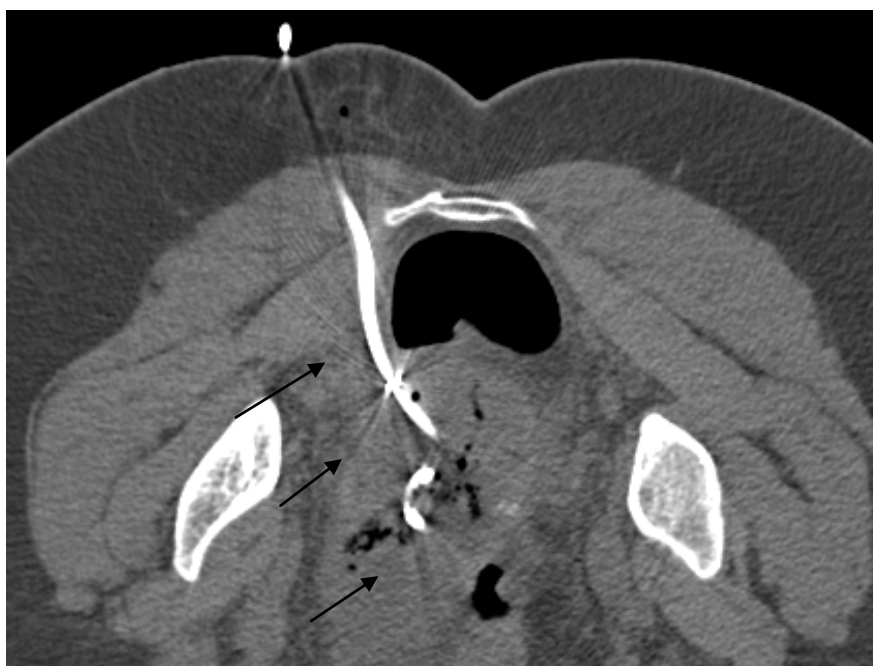
Figure 2: Axial Image of a computed Tomography that demonstrates a 12 F drainage catheter inserted via right transgluteal approach (Black arrows) into the pelvic abscess collection.

was a diagnostic confusion of retained surgical with hematoma mimicking an abscess; in view of her persistent symptoms decided to proceed with aspiration. She underwent CT guided drainage of the pelvic collection with pigtail catheter placement through transgluteal approach (Figure 2). Only 10 ml of serosanguinous fluid was obtained despite the appearance of big hematoma on CT scan. Pigtail catheter was kept in for 48 hours with only minimal drainage. Culture of the aspirate did not show any growth. Histopathology of the surgical specimen showed multiple leiomyoma, adenomyosis, endometrial polyp and complex hyperplasia of endometrium.
